TRMM Monthly Status Briefing

January 12, 2000

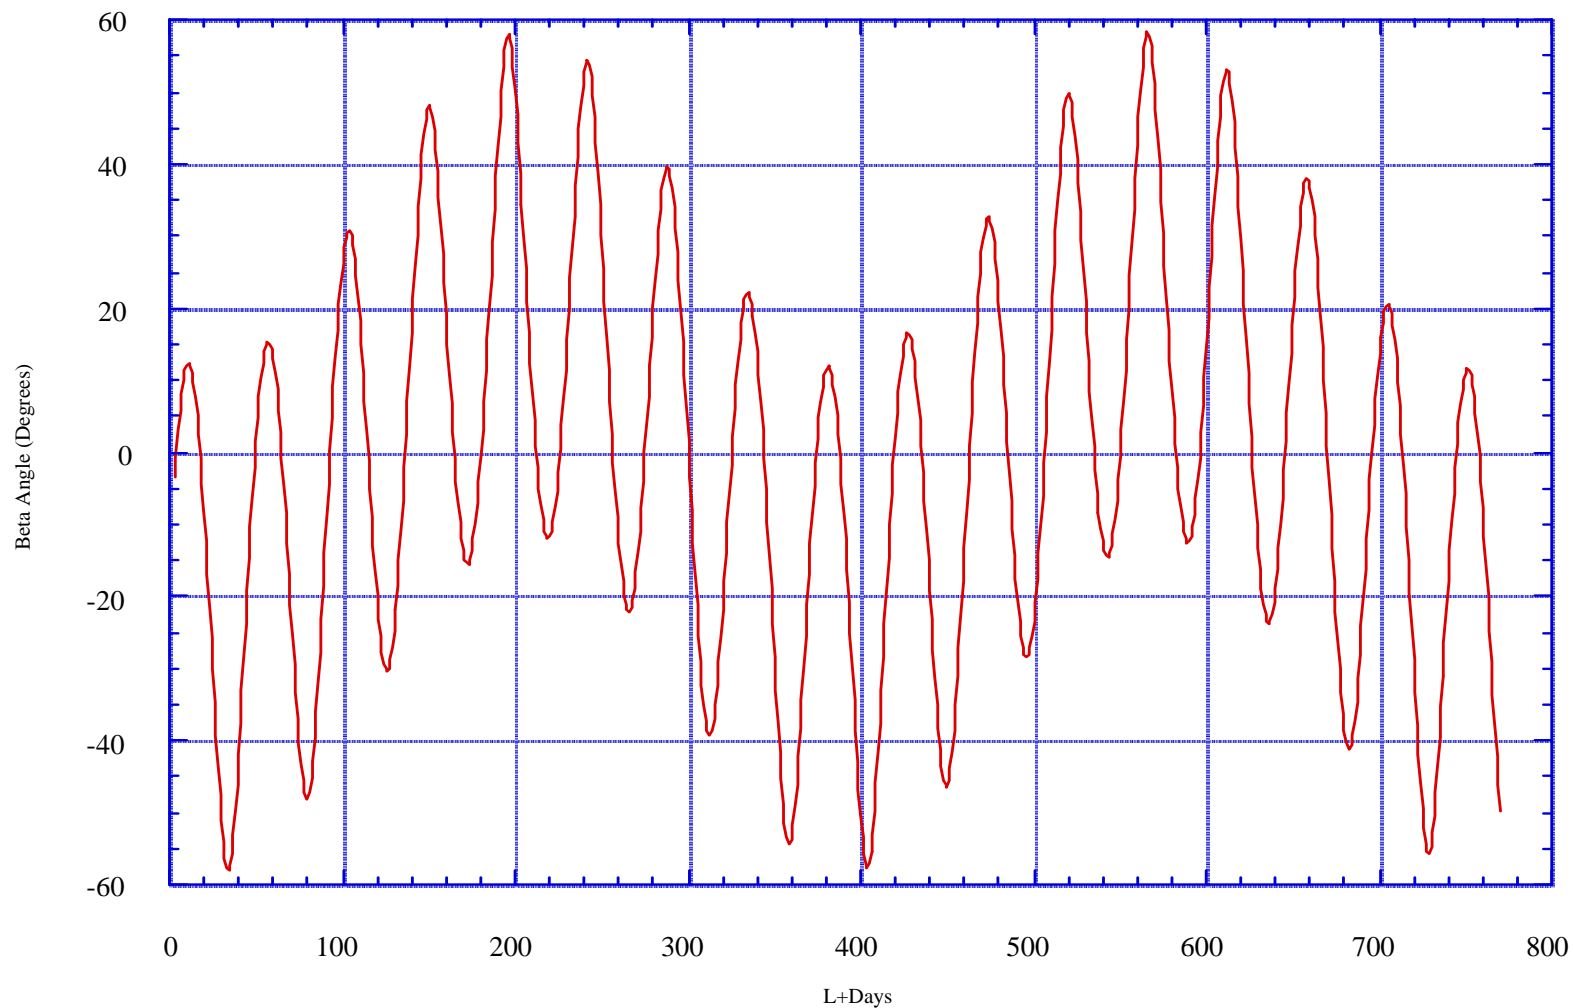
TRMM Solar Beta Angle Since Launch

- Solar Beta angle cycle
 - Biggest influence on thermal behaviors
 - Two peaks per year at $+58^\circ$ and -58°
- High thermal conditions experienced on solar array drive remains a serious concern
- Thermal data being provided on monthly basis to Code 540 for analysis
 - Started in October 1999

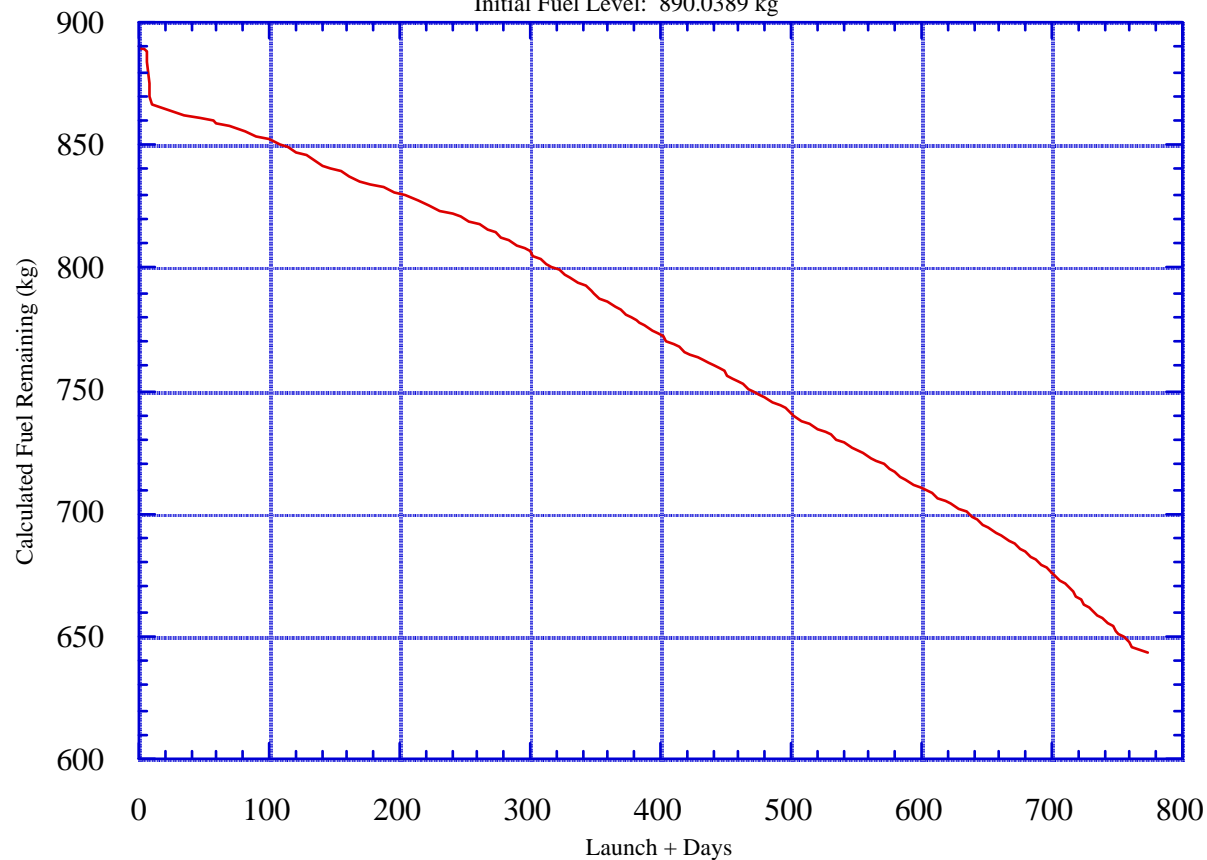
TRMM Hydrazine Fuel Usage Summary

- Current mission life estimate is 6.4 years from launch if predicted solar flux levels continue (primary mission: 3 years)
- Reasons
 - » Predicted nominal pressure: 170 psia; Observed: 167.7 psia
 - » Thruster performance 5% better than pre-launch estimates
 - » Solar Flux levels in 98 and 99 lower than predicted
- Spreadsheet developed by FOT with RCS Code 713 engineers
 - » Outputs expected life by relating average daily fuel consumption with predicted solar flux levels
 - » Updated monthly

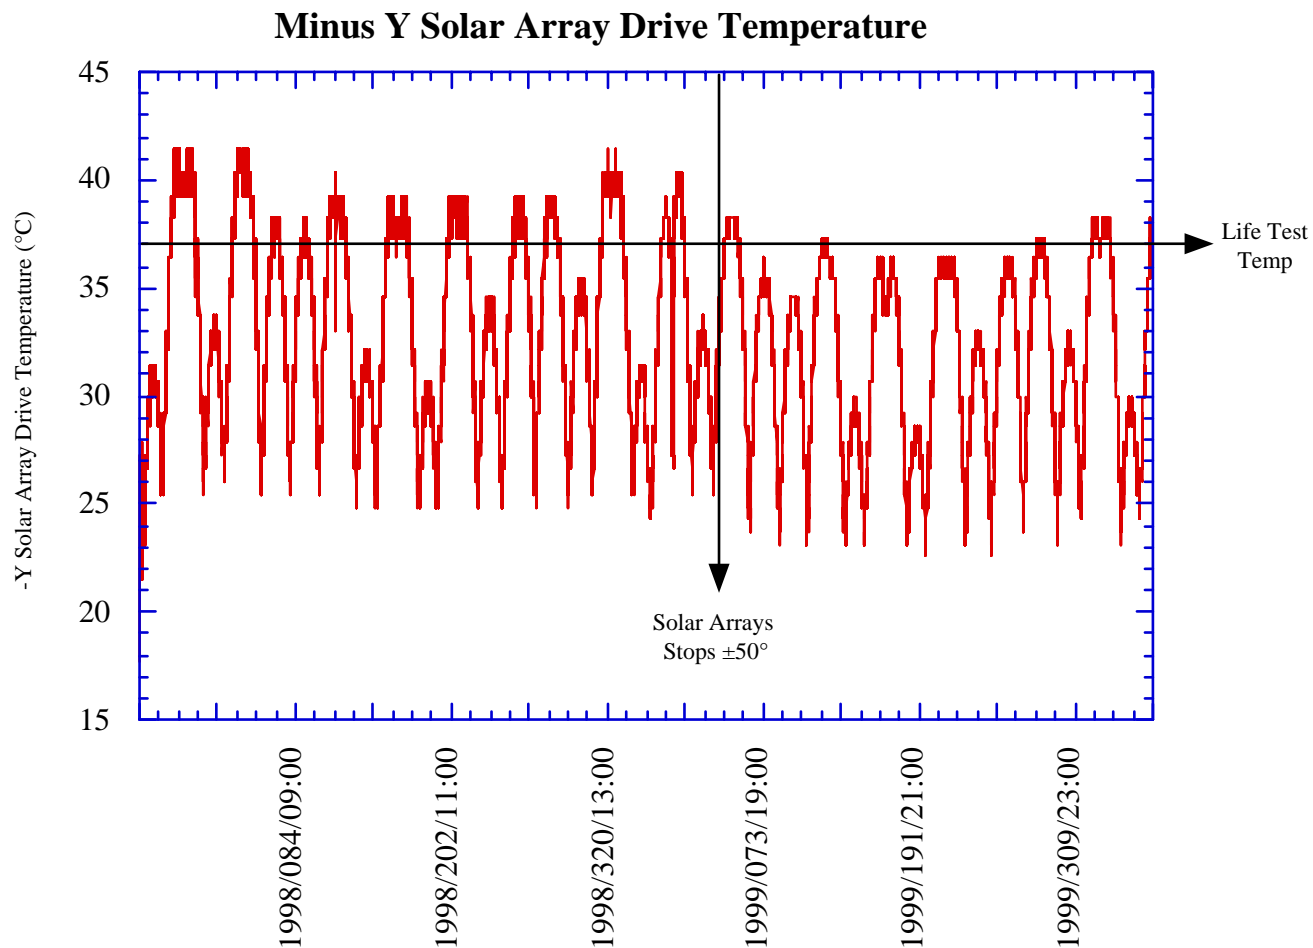
- -Y solar array drive temperature
 - A 10° C increase in temperature is 100 times more likely to evaporate the lubricant and may potentially cause undetected levels of metal particles
 - » Bearing temperature cannot be measured directly
 - Reaches maximum temperature at approximately beta angle 48° C
 - Has exceeded life test temperature of 37° C numerous times
 - » After solar array software stops were limited permanently to $\pm 50^\circ$ (originally $\pm 130^\circ$); drive temperature has been a few degrees cooler (see plot on next slide)
 - Currently solar array drive continues to operate with no signs of slippage

- -Y Solar Array Readiness Review held in June 99
 - Will not park -Y solar array at 30°; will remain with the status quo
 - FOT now focuses on detection of failed array
 - » Checklist
 - » TSMs for sensed vs commanded position
 - » On-console training includes solar array failure identification and early contingency steps
- Open Issues
 - Deployables AETD looking into the possibility of loading solar array stops to track past 90° to check the glitch buffer
 - » Risk Analysis to be conducted first

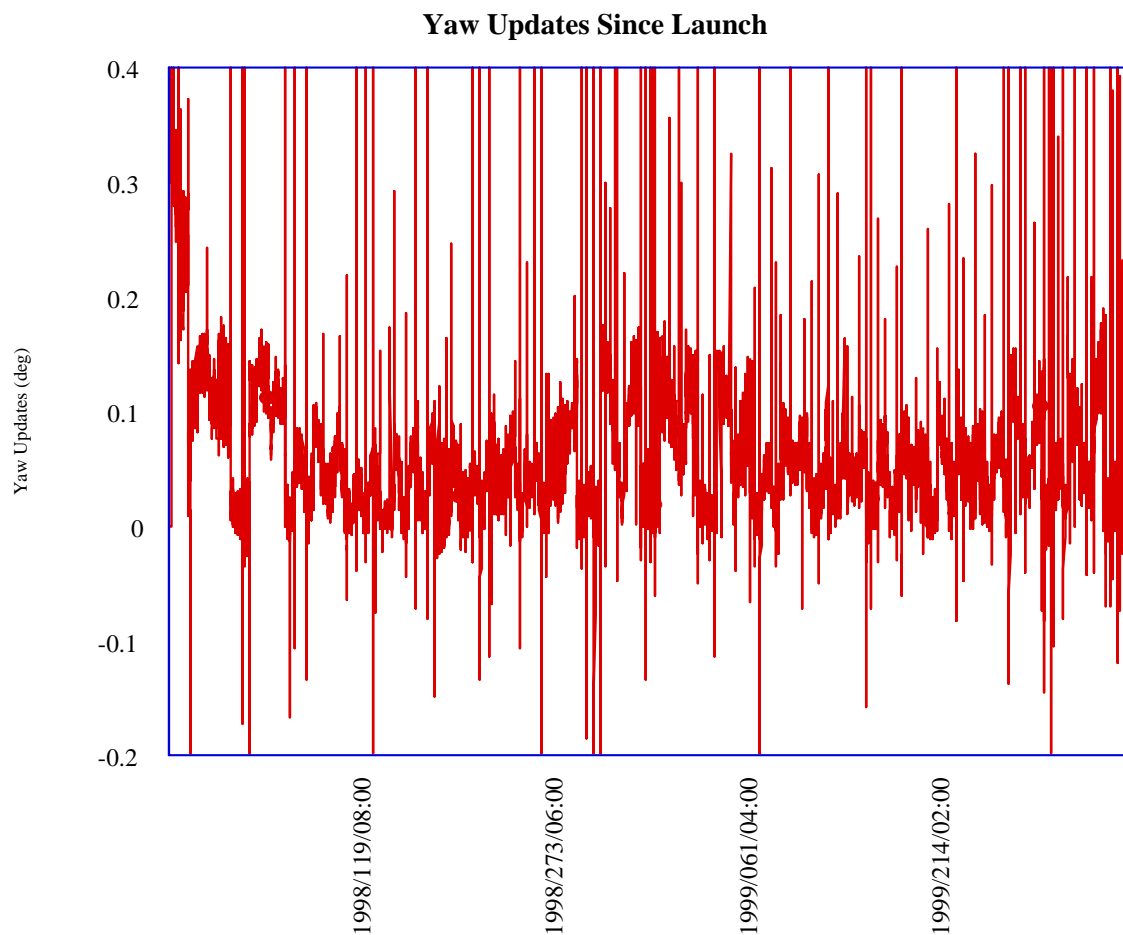
- 2 Sun Acq occurrences since launch - limits set too tight; no actual problems with spacecraft
- Solar Array jitter (AR #74)
 - Experienced when Beta angle is above $\pm 54^\circ$
 - ACS software patch (CCR #052) used to reduce affect
 - » Change Solar Array Sun tracking code
 - Now uses Sun position based on the nominal attitude, instead of unfiltered gyro data
 - No problems experienced at last 2 Beta angle peaks: 99-328 (-55°) and 00-009 (-57°)
- Yaw updates show seasonal changes
 - Worst case still exceeds 1σ specifications
 - Believed to be due to ESA behavior

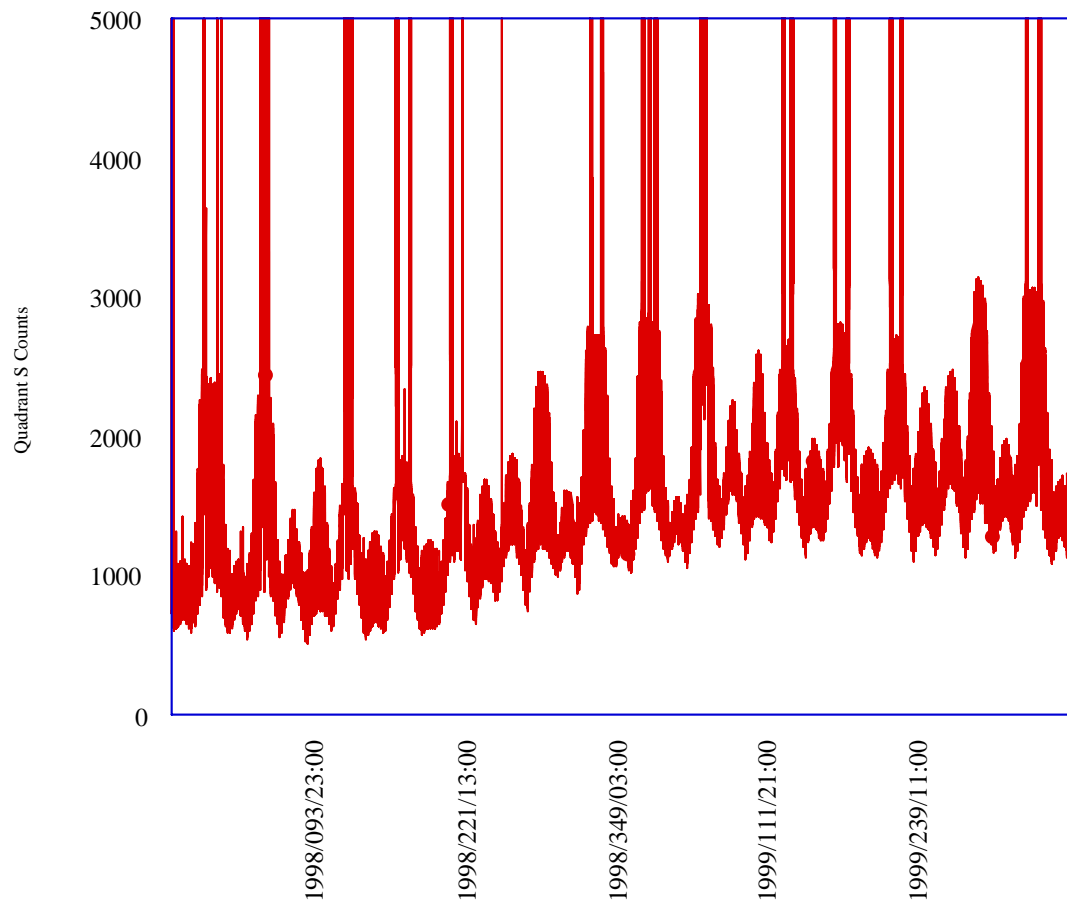
ESA S Counts for Quadrant 1

- TDRS EPVs still sometimes fail in position and velocity following TDRS maneuvers (AR #60 - CCR #035)
 - New table 85 with updated position & velocity limits uplinked
 - » Position Limit increased from 400 to 850 km
 - » Velocity Limit increased from 0.3 to 0.62 km/s
- ESA fogging
 - Focused in Quadrant 1
 - Action threshold is ~2500 counts
 - » Look into table bias changes
 - Manufacturer (Barnes) is not concerned with current performance

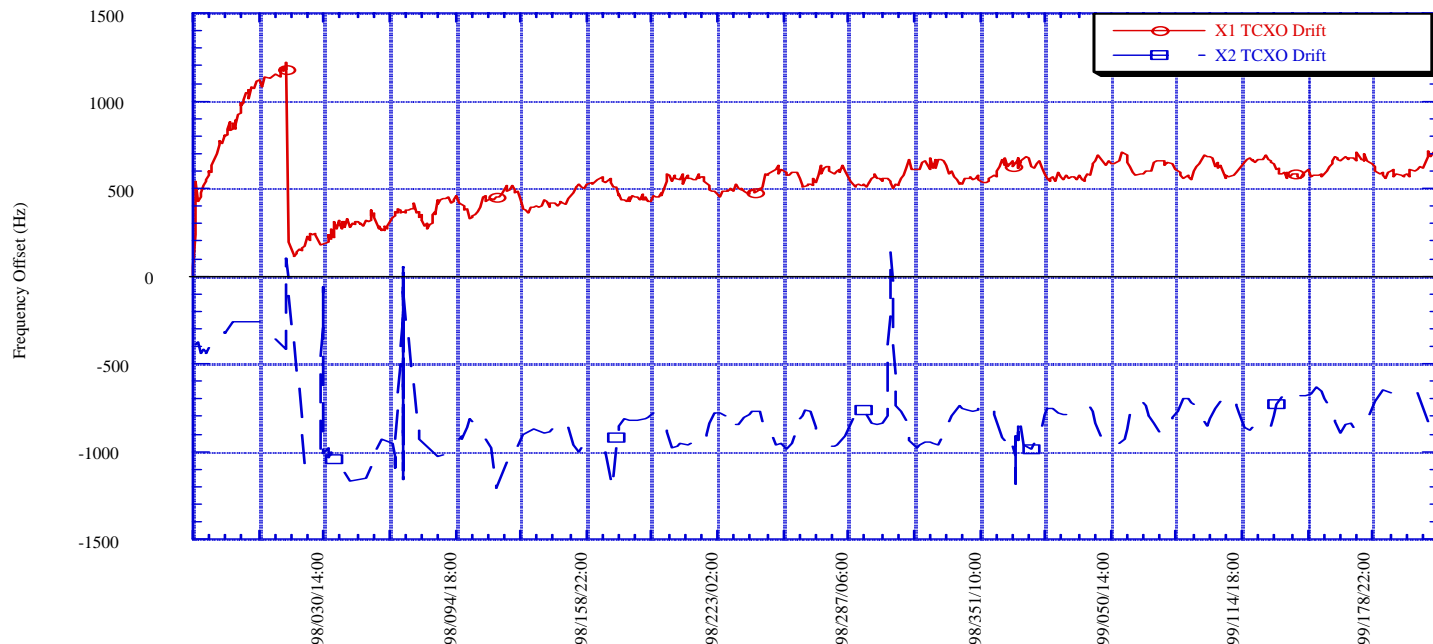
- Frequencies settled at approximately ± 700 Hz and drifting slightly
 - XP1 offset trended once a day, XP2 three times a week

- Frequency Offset is ‘forgotten’ upon deacquisition
- Generic Late Acquisitions (99-365)
 - No indication of subsystem problem
 - Mostly seen on TDRS West

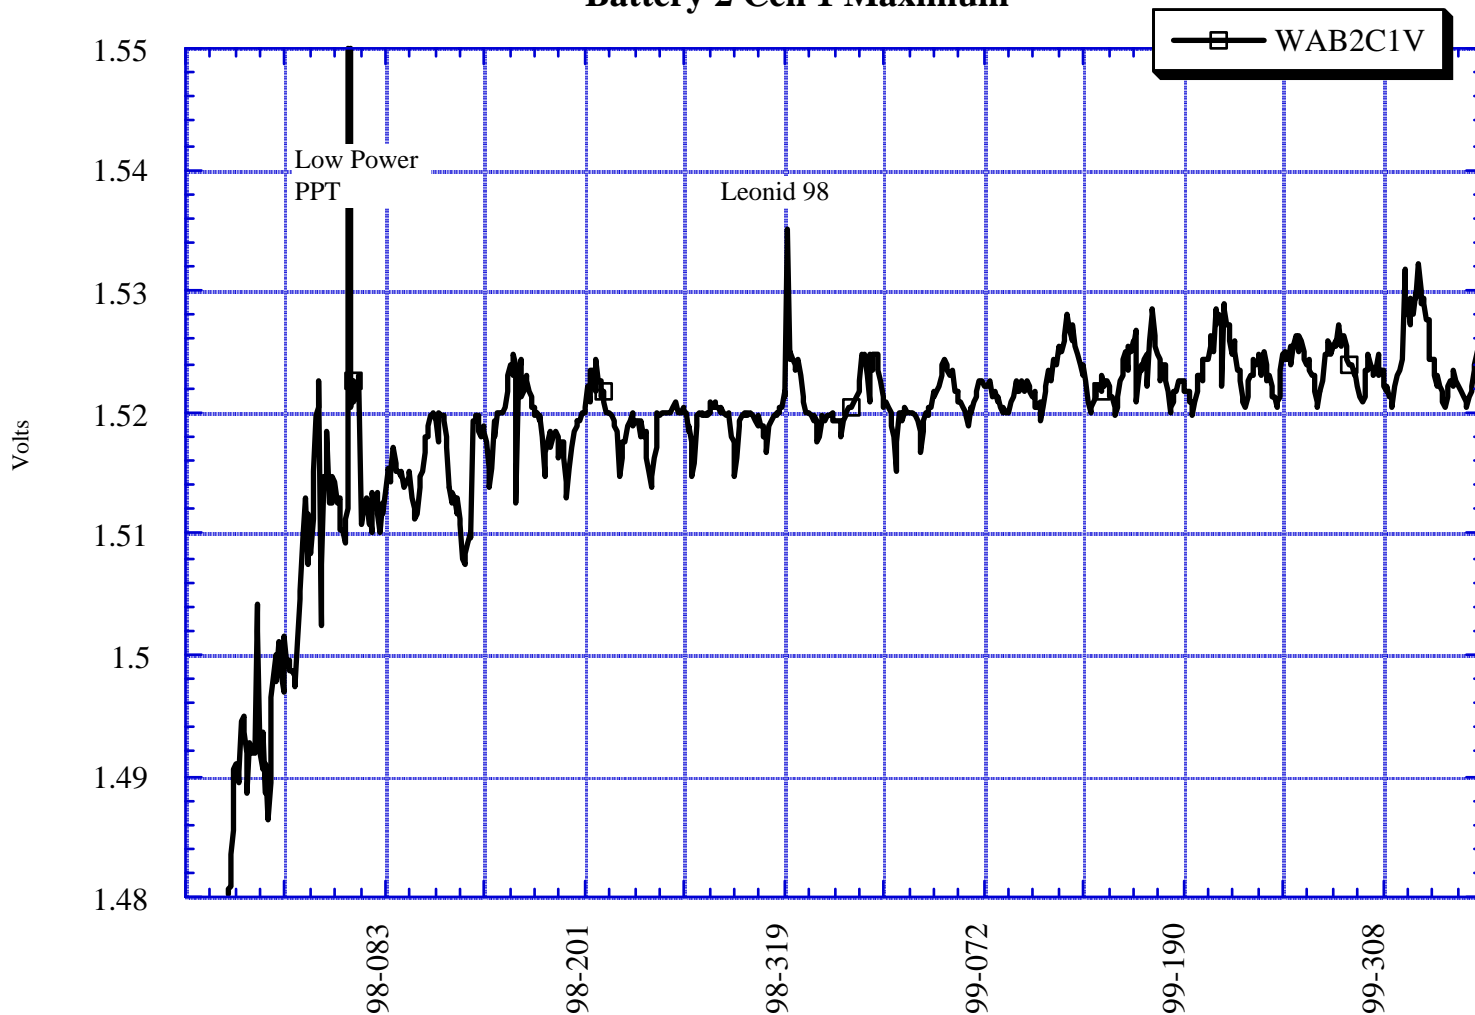
Battery 2 Cell 1 Maximum

- Power analysis reports and trending provided to Code 563
- State of Charge counters not reaching 100% for all orbits at low Beta angles
 - C/D changed to 1.02 on 99-138 after TSMs # 31 and 32 limits reached (currently at 1.025)
- Battery 2 Cell 1 high cell voltage Anomaly #55 (on 98-028)
 - On 98-062, PSIB B turned on to rule out telemetry problem
 - TSMs #31 - 34 and RTS #13 added to prevent PSIB misconfiguration (EOD SOC drops below 95%)
 - Several charge setting changes to reduce peak - no effect
 - Report made “Inactive”
 - » Manufacturer has not given satisfactory explanation to close report

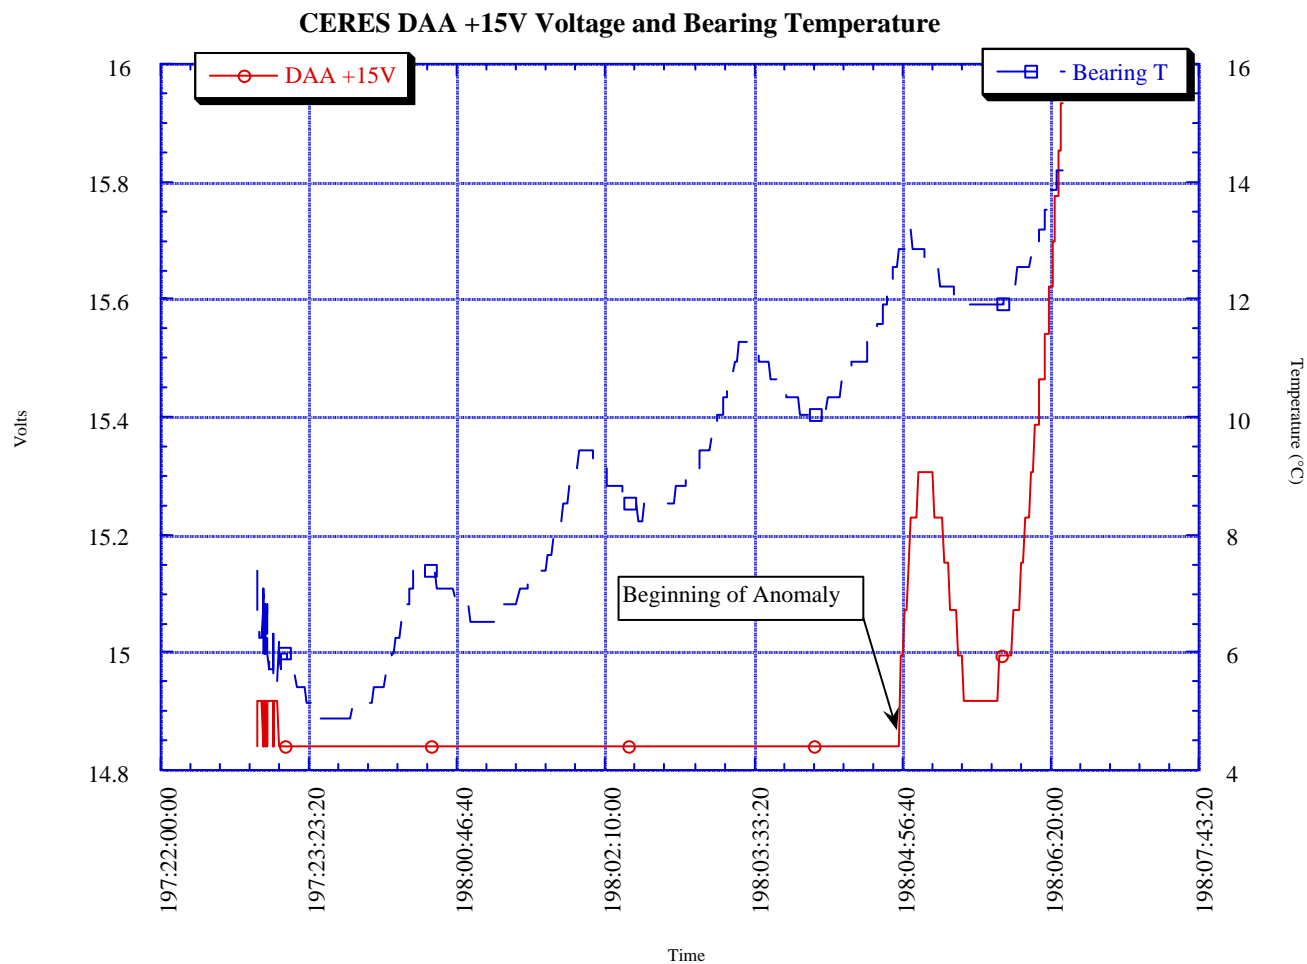
- AR #69: +15 V Data Acquisition Assembly (DAA) converter voltage hit high limits on 98-230
 - Powered OFF 98-244
 - Powered ON for short periods to coordinate science testing with other instruments and ground sites: ScaRaB instrument, INDOEX, Hawaii, and Australia
 - The LaRC *CERES +15V Anomaly Report* details the cause of the converter failure

- Next turn on period will be determined by Terra checkout (Jan 27)
 - Will most likely not power OFF again due to converter voltage reading saturation
- Removal from ACS contingency load-shed plan
 - Powered off in Low Power conditions
 - Plan and Test result walk-through held on Dec. 15th
 - Awaiting final approval to place on board
- Open issues
 - Awaiting official closure of AR #69
 - » CERES DAA High Voltage on +15 V converter
 - Awaiting new TSMs for CERES current monitoring (CCR #045)
 - » Testing complete
